REPORT OF THE GROUP

**FREQUENT TRIPPING OF PANIPAT, MAU
AND MURADNAGAR S/STNS IN
NORTHERN REGION**

**NORTHERN REGIONAL POWER COMMITTEE
New Delhi
FEB 2010**

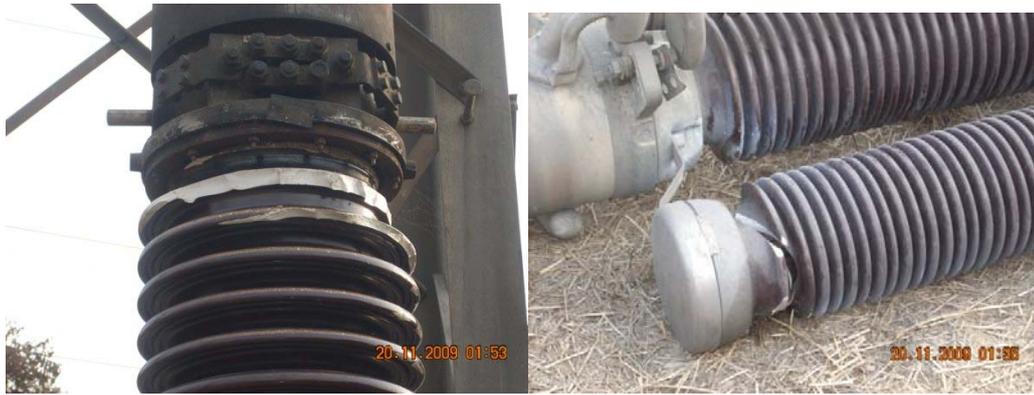
- 2.6. During interaction with the Group members, substation authorities expressed apprehension that in some of the flashover incidents, there appears to be direct arcing through the air between the metallic parts. This apprehension was based on the premise that in some such flashover incidents, metallic parts which are not even in shortest aerial path have been damaged. Some pictures of such damaged equipment are shown below:

- 2.7. The Group is of the opinion that such direct flashover through the air without tracking through insulator may not have happened. However, when flashover takes place through the insulator, the air in the vicinity gets ionized and thereafter arcing through the air may follow. Therefore, Group members are of the opinion that primary cause of flashover through the air is tracking through the insulators. The Group recommends that wherever flashover through the air has been observed, the insulators should be replaced because they would have developed inherent weakness due to flashover. In order to avoid insulator flashover at the substation, the group opines that whenever new insulators are procured for replacing existing insulators, the specifications in respect of creepage distance should be enhanced to 35 mm / kV as against existing norm of 25 mm/kV. The Group also recommends that Basic Insulation Level for new equipment may also be increased.

- 6.9 Wherever flashover through the air has been observed, the insulators should be replaced in time bound manner. **(Time frame: 6 months)**
- 6.10 Wherever required, wiring used for protection and instrumentation should be replaced. **(Time frame: within 3 months)**
