Report of the Group on
**Incidents Rihand Station Outage and tripping of Rihand-Dadri Pole on
18 & 19 June 2013**

1. A group of engineers from NRPC, NLDC, NRLDC, POWERGRID and NTPC was constituted by Member Secretary, NRPC vide letter No. NRPC/OPR/105/10/41823 dated 19.06.2013 (copy enclosed as Annex) to investigate the incidents of complete outage of Rihand STPS Stage-I, II and III and tripping of Rihand-Dadri Pole 2 which occurred on 18-19 June 2013. The group met at NRPC office on 21.06.2013 and discussed the incident in detail. The findings of the group and suggestions for improvement for future are discussed in the succeeding paragraphs.

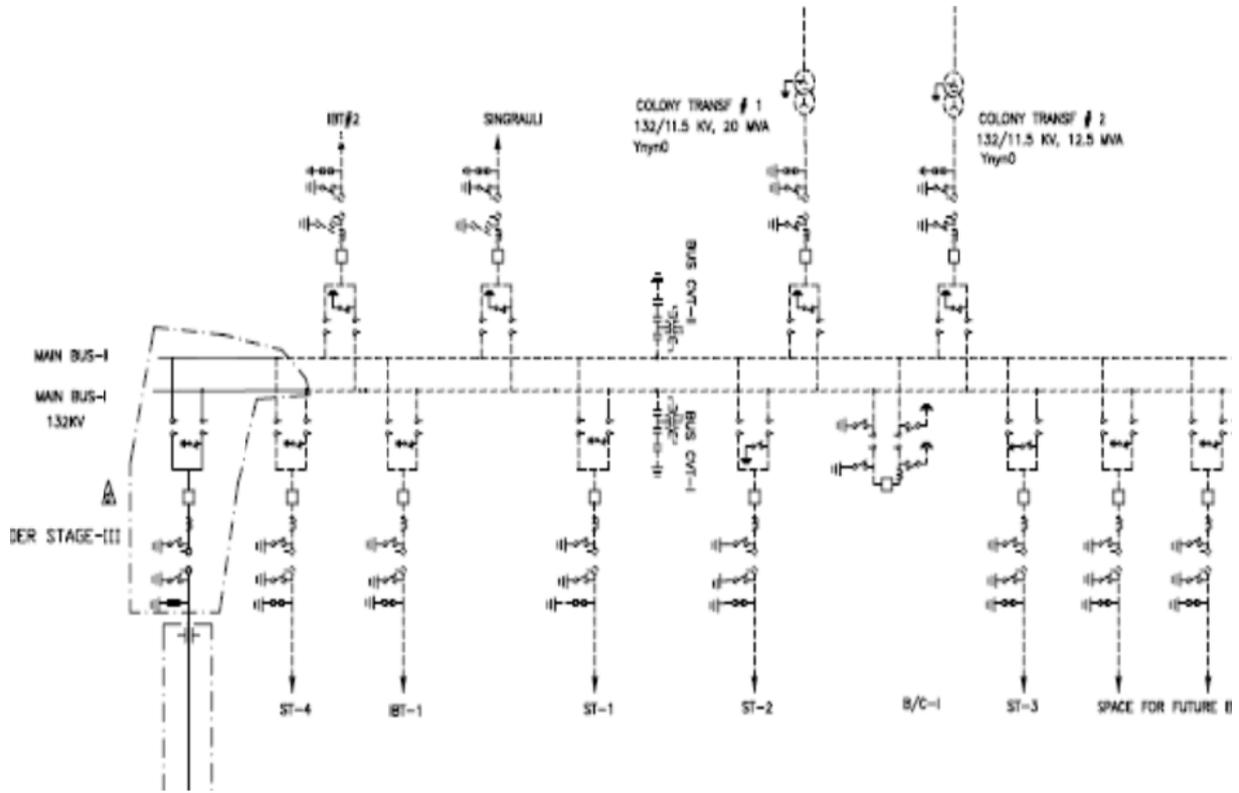
Exhibit-1

3.1 The 132 kV Intermediate Voltage Switchyard is designed with Two Main Bus scheme, with a Bus Coupler between the two Bus Bars. A single line diagram of the Switchyard is enclosed as Exhibit-1. The 132kV system catering to Stage-1 & Stage-2 had been provided with 2 x 400/132kV IBTs of 200MVA each. The 132kV bus in turn feeds the four Station Transformers catering to the four units of Stage-I and Stage-II.

3.3 On 18.06.2013 at 21.14hrs, while the area was experiencing thunder storm and rain, the 132kV CT of the B/C bay failed, resulting in a bus fault and 132kV Bus#2 tripped appropriately on Bus Bar Differential Protection. IBT#2 was thus removed from service and the only 132kV source was lost, resulting in loss of Station Auxiliary Supply in stage-1 and Stage-2. The Fault as recorded in PMUs available at NRLDC is as enclosed at Exhibit-2.

- i. IBT#1 to be commissioned as early as possible and IBT#3 to be expedited.
- ii. NTPC may examine the possibility of providing a double Breaker connection option for the third IBT, to either Bus Bar. In the event of tripping of any one IBT or any one 132kV Bus Bar, two IBTs will still be available in service.

- iii. NTPC may examine the possibility of providing two Circuit Breakers and two sets of CTs in the B/C bay. This option will eliminate the possibility of a single fault causing tripping of both 132kV Bus Bars.

- vii. Till either suggestion iii or iv stated above is realized, 132kV B/C may be normally kept open and isolated, with each bus being fed separately by one IBT.

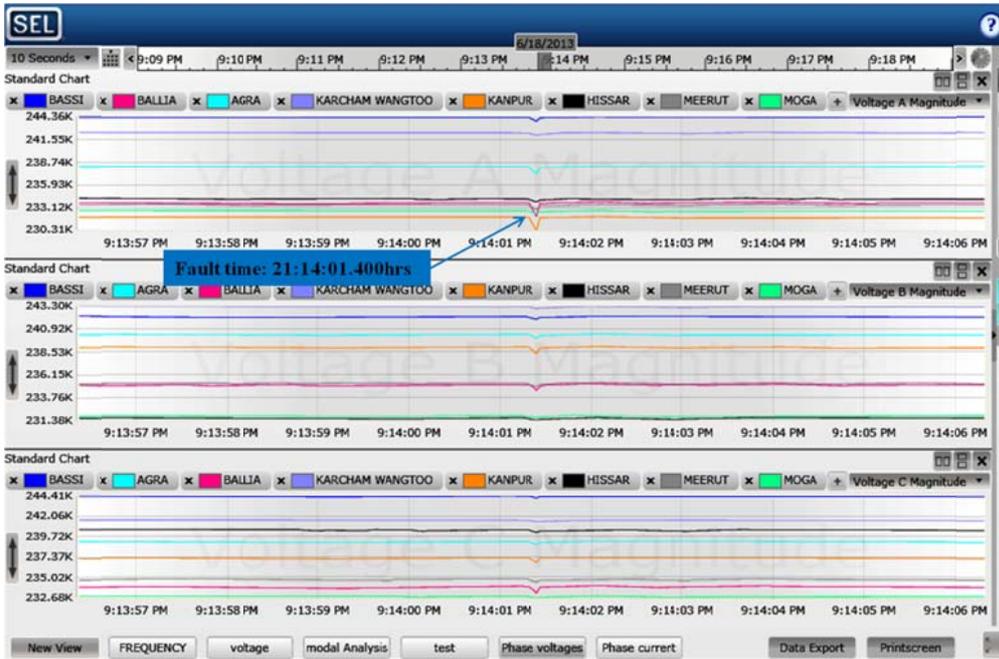
Fig: PMU plots of phase voltage at different stations

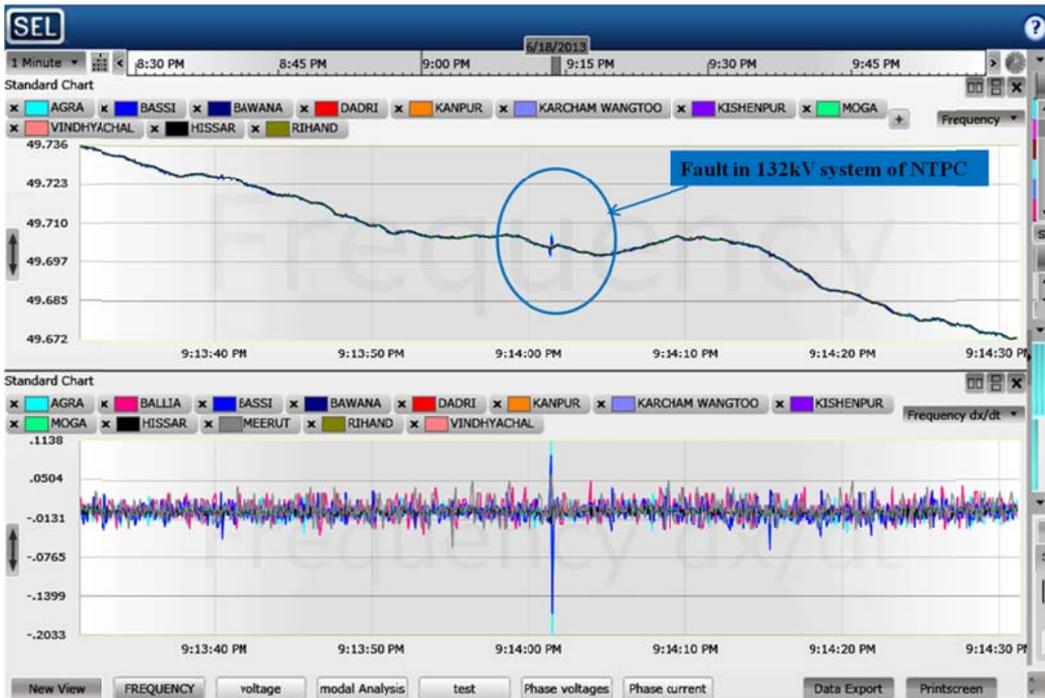
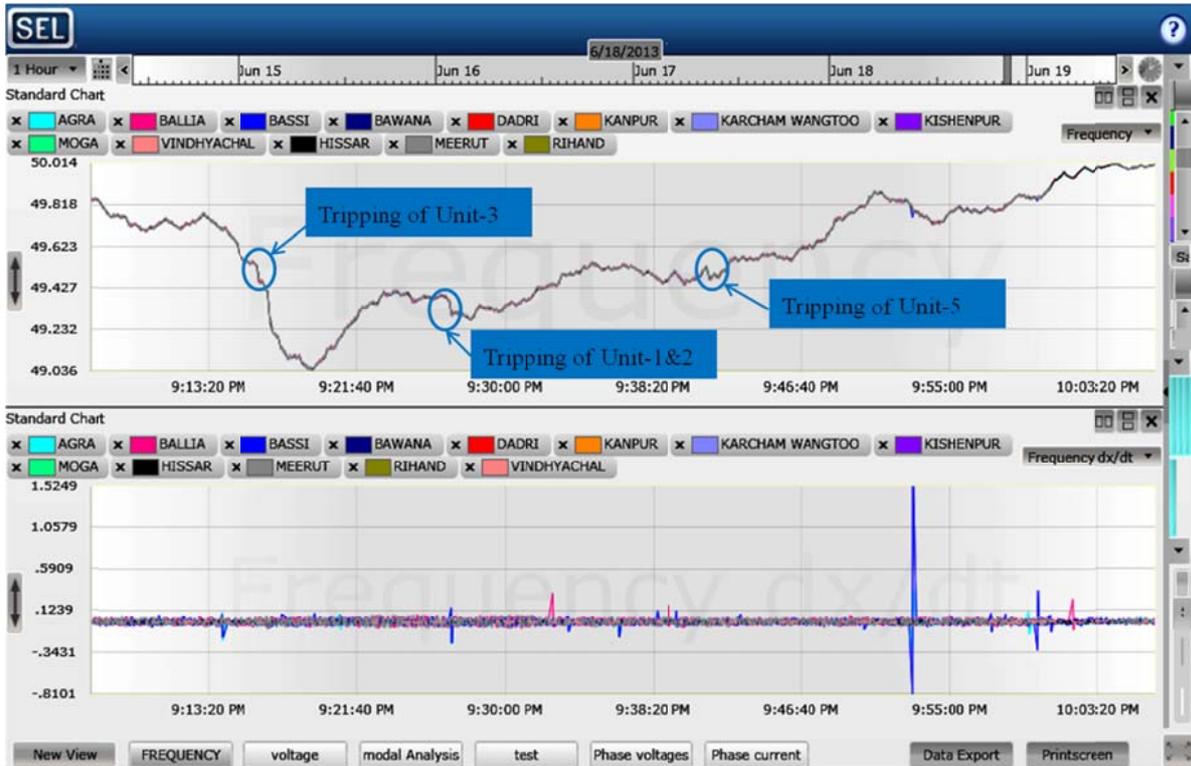
The outage of different units has also been recorded in frequency plot of the PMUs while no fault is seen during these unit outages. The frequency plot of PMU is attached as Exhibit-3.

Fig: Frequency and df/dt plot of different stations

Fig: Frequency plot at different PMU locations during the Rihand incident

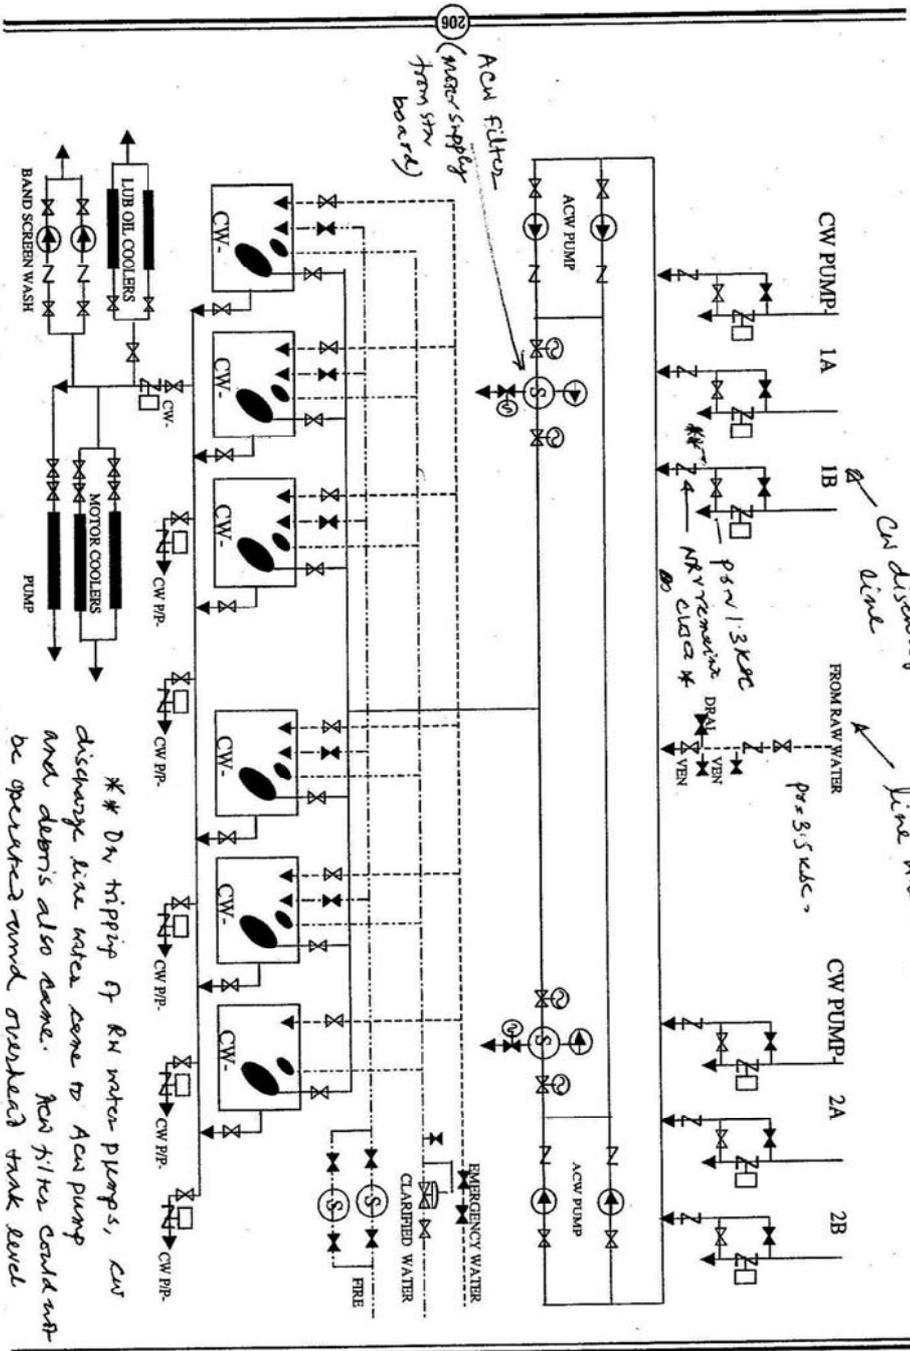
5.1 The tripping root cause for each unit of the Station during this incident is discussed below in the chronological order of tripping. The schematic of auxiliary cooling water system is enclosed as Exhibit-4.

2. **Unit # 3 (21:16:42:323):** Unit # 3 & 4 were operating with CW system interconnected, with four CW pumps in operation. Two pumps of Unit # 4 (4A & 4B) were fed from Unit supply and two pumps of Unit # 3 (3B & 3C) were fed, one pump each, from Unit and Station supply respectively. On tripping of IBT # 2. Pump 3C tripped and pumps 4A and 4B tripped when Unit # 4 tripped. Pump 3A took auto start and two pumps were feeding the condensers of operating Unit#3 & Tripped Unit#4. With the 2 CW pumps in service and both unit 3 & 4 condensers in charged condition, condenser vacuum started falling and Unit#3 tripped on Condenser Vacuum Low Protection.

3. **Unit # 1(21:26:51:719):** CW pump 1C, fed from Station supply, tripped on failure of 132KV supply. Unit Supply fed running CW pumps tripped later on cooling water flow low protection as CW cooling water overhead tank level became low. The over head tank supplies water for bearing lube-water and lube oil coolers. Make up for over head tank was being supplied from RW water pump fed from Station Supply and the pumps tripped on Station Auxiliary Supply failure. Alternate source from CW discharge water to overhead tank came into service but debris which came through this line choked the ACW filters and finally water did not reach to overhead tank. Scheme of ACW system is enclosed as Exhibit-2. It may be pointed out that CW of Rihand Station gets lot of debris during rains. The power supply to the filter flushing system from Station supply was not available. Condenser vacuum started falling and load was reduced to 300MW from 449MW by cutting one mill. Unit 1 tripped on condenser vacuum low

In normal op. NRV remains closed as RW water pressure high

* Dry tripping of RW water pumps, CW discharge line notes come to ACW pump and debris also come. RW filter could not be operated and overload tank level became low.

- viii. Unitization of power supplies may be explored for CW Pump House LT auxiliaries as well.

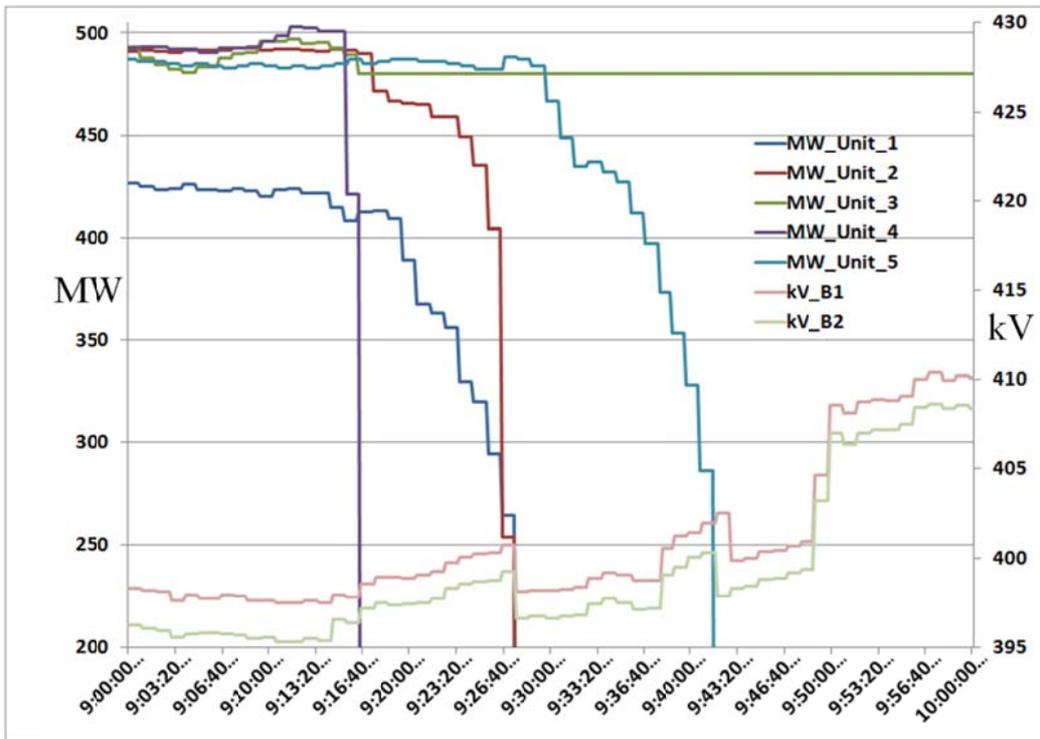
Exhibit-5

5.2 The plots based on SCADA data as available at NRLDC for various units, bus voltage and lines flows at Rihand is as attached at Exhibit-5. It needs to be seen that values for unit # 3 got frozen after the tripping:

Fig: SCADA plots for Rihand bus voltage and rihand units power output.

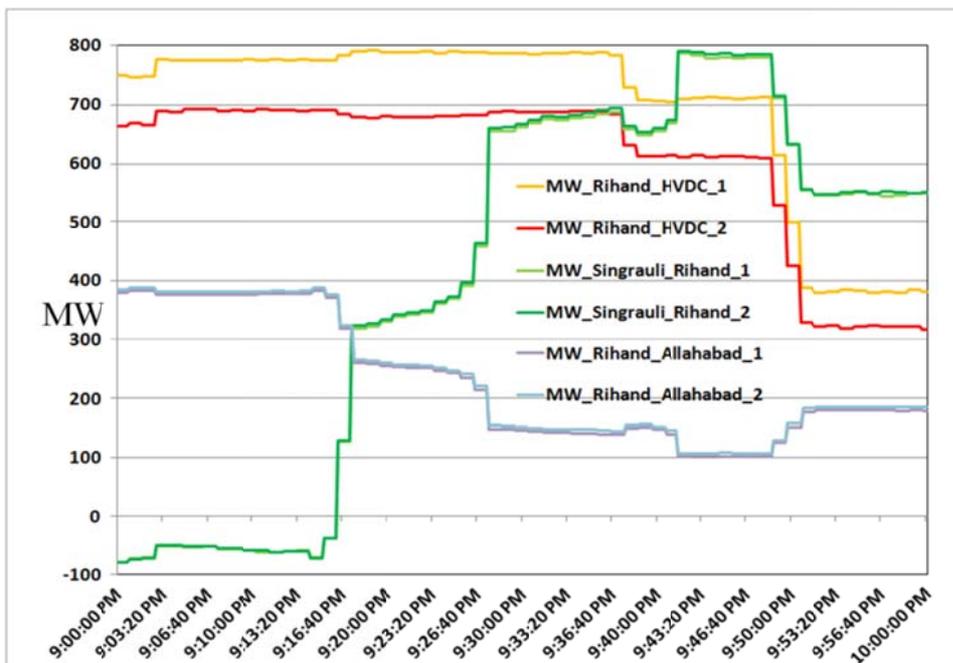
Fig: Power flow on different lines from Rihand STPS
