**Northern Regional Power committee
New Delhi**

Report on Frequent Tripping of Pragati GT

Report of the Sub-Committee to look into the frequent tripping of Pragati GT

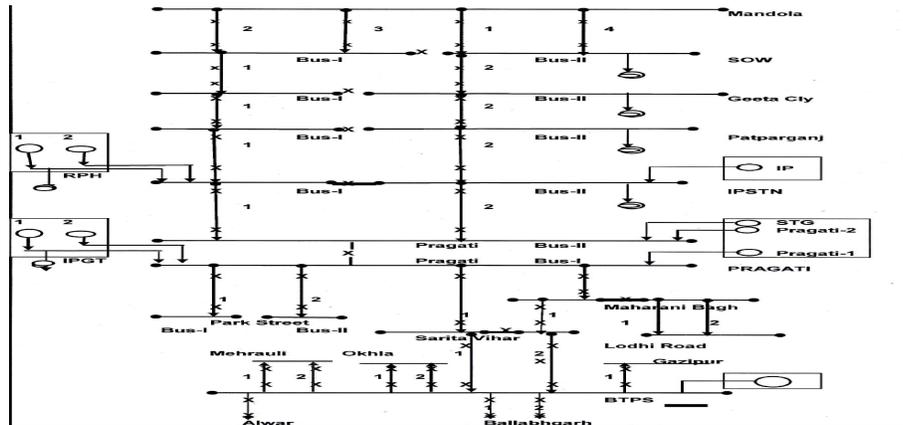
Pragati GT Power Station has 2 GT units of 104.6 MW each and one STG of 121.2 MW. Normally Pragati GT-1 is connected to Bus-1 and GT-2 along with STG is connected to Bus-2 of Pragati sub-station of DTL as shown in the diagram.

The units of IPGT are connected on the bus of Pragati GT-1 through two transformers maintained by DTL. A bus coupler which is generally kept open to split 220 kV system of Delhi has been provided at Pragati DTL substation.

Bus-1 has 4 feeders which are connected to 220 kV lines to Maharani Bagh, Sarita Vihar, Park Street -1 and Park Street -2. Sarita Vihar is further connected to BTPS.

GT-2 and STG is generally connected to Bus-2 to form part of grid connecting through IP station, Patparganj, Geeta Colony to south of Wazirabad and Mandola substation.

1. Reviewing of Bus split at Pragati GT- Since Bus -II of Pragati S/Stn has only two feeders, in order to increase reliability of supply in the region, the sub committee recommends that SLDC Delhi in consultation with NRLDC should undertake a study to review the 220 kV Bus split at Pragati GT and suggest re- configuration or additional evacuation for Pragati. **[Action – SLDC Delhi/ NRLDC, Time – one month]**

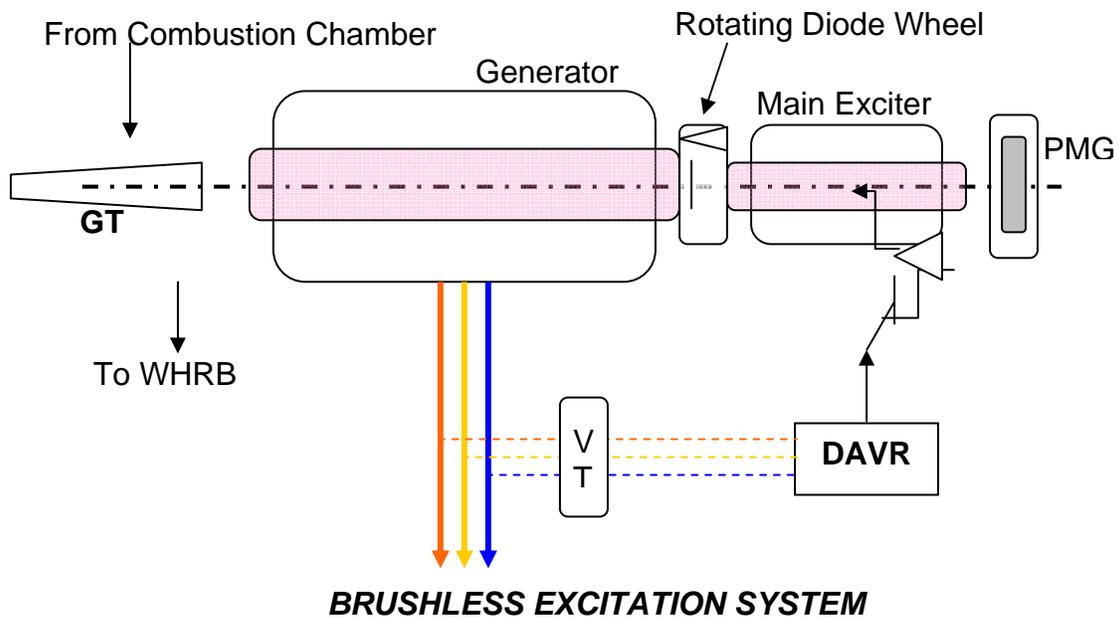
Pragati GT units are equipped with brushless excitation system. Excitation control being performed by the DAVR (Digital Automatic Voltage Regulator) manufactured by BHEL. In brushless excitation system, excitation power is derived in two stages by two shaft driven auxiliary generators. The former machine a Permanent Magnet Generator (PMG) carries permanent magnets on its rotor. The three phase high frequency AC supply extracted from its stator is rectified in a controlled rectifier and fed to the field winding wound in the stator of the latter machine, the main exciter. The three phase armature winding of the main exciter is wound on its rotor which is rectified in rotating rectifier, mounted on the shaft itself and is fed directly into the field winding of the main generator rotor. The voltage regulation is applied by the DAVR at the controlled rectifier in the field circuit of the main exciter. The block diagram of the arrangement is shown in the sketch below:

DAVR is equipped with dual auto channel control for normal operation. Each auto channel gets its voltage feedback from a separate VT connected to the generator terminals. In the event of a failure of VT signal, detected by a Voltage Balance VT fail detection scheme provided in the GRP (Generator Relay Panel), the control will transfer from Auto Channel-1 to Channel-2 and the machine will continue to operate normally. However, in case there is no real VT failure also, VT fail condition can be detected by the scheme during transient voltage sag and recovery during a close in fault. In such a situation the VT fail condition can be detected by the Voltage Balance Scheme for both AVR VTs for a short while due to the mismatch of VT characteristic and relay operating characteristic. In such cases both auto channels would fail and switch off and the machine would eventually trip on loss of excitation. This is possibility for machines which are susceptible to close in faults which is very much the case with Pragati units.

1. Pragati station in consultation with BHEL, has now decided to incorporate a time delay of the order of 500ms in the VT failure detection based channel change-over logic. The sub committee finds merit in the proposal and feels that the time delay may be kept 200ms more than the Zone-2 time delay in DTL system
2. The new DAVR being supplied by BHEL has two additional manual channels inherently and the loss of both auto channels would not result in unit outage.
3. BHEL DAVR is some times equipped with an in built VT failure detection logic. It needs to be confirmed that such a scheme if existing is also having time delay feature.

2. Reviewing of setting of excitation system of Pragati Units- Pragati station has in consultation with BHEL, has now decided to incorporate a time delay of the order of 500ms in the VT failure detection based channel change over logic. The sub committee finds merit in the proposal and feels that the time delay may be kept 200ms more than the Zone-2 time delay in DTL system. The same setting may further be extended to unit 2 if found successful. **[Action – PPCL, Time – three month]**

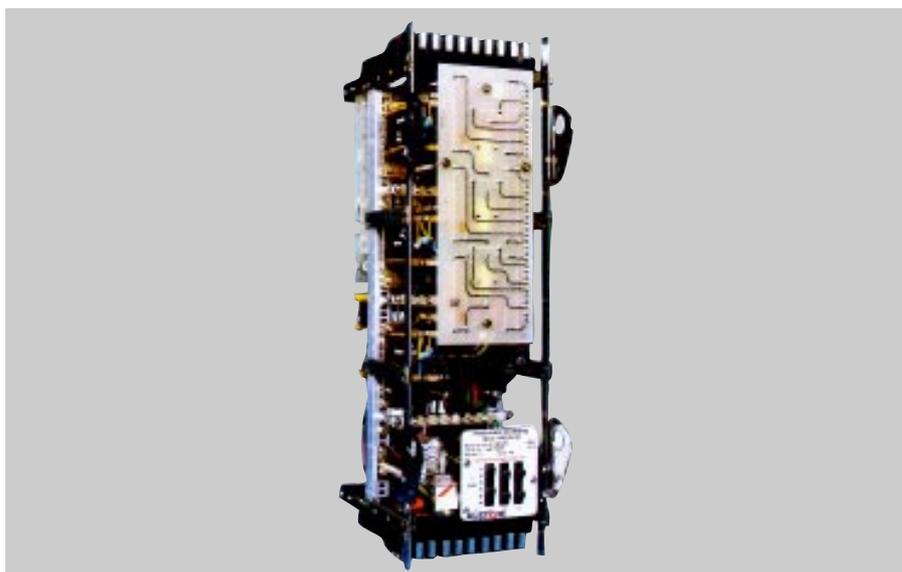
DTH relay
withdrawn from case

DTH 31 and DTH 32 are triple pole high speed biased differential relays – DTTM 11/DTTM 12 are single pole versions of DTH 31/DTH 32 respectively – designed to protect large power transformers, auto transformers and generator transformers against internal faults. Biased to provide stability during heavy through-faults, the relays utilise second harmonic restraint to prevent operation by normal magnetising in-rush currents produced when the transformer is energised.

In addition, type DTH/DTTM relays employ fifth harmonic by-pass circuit to avoid possible mal-operation under over-excited conditions.

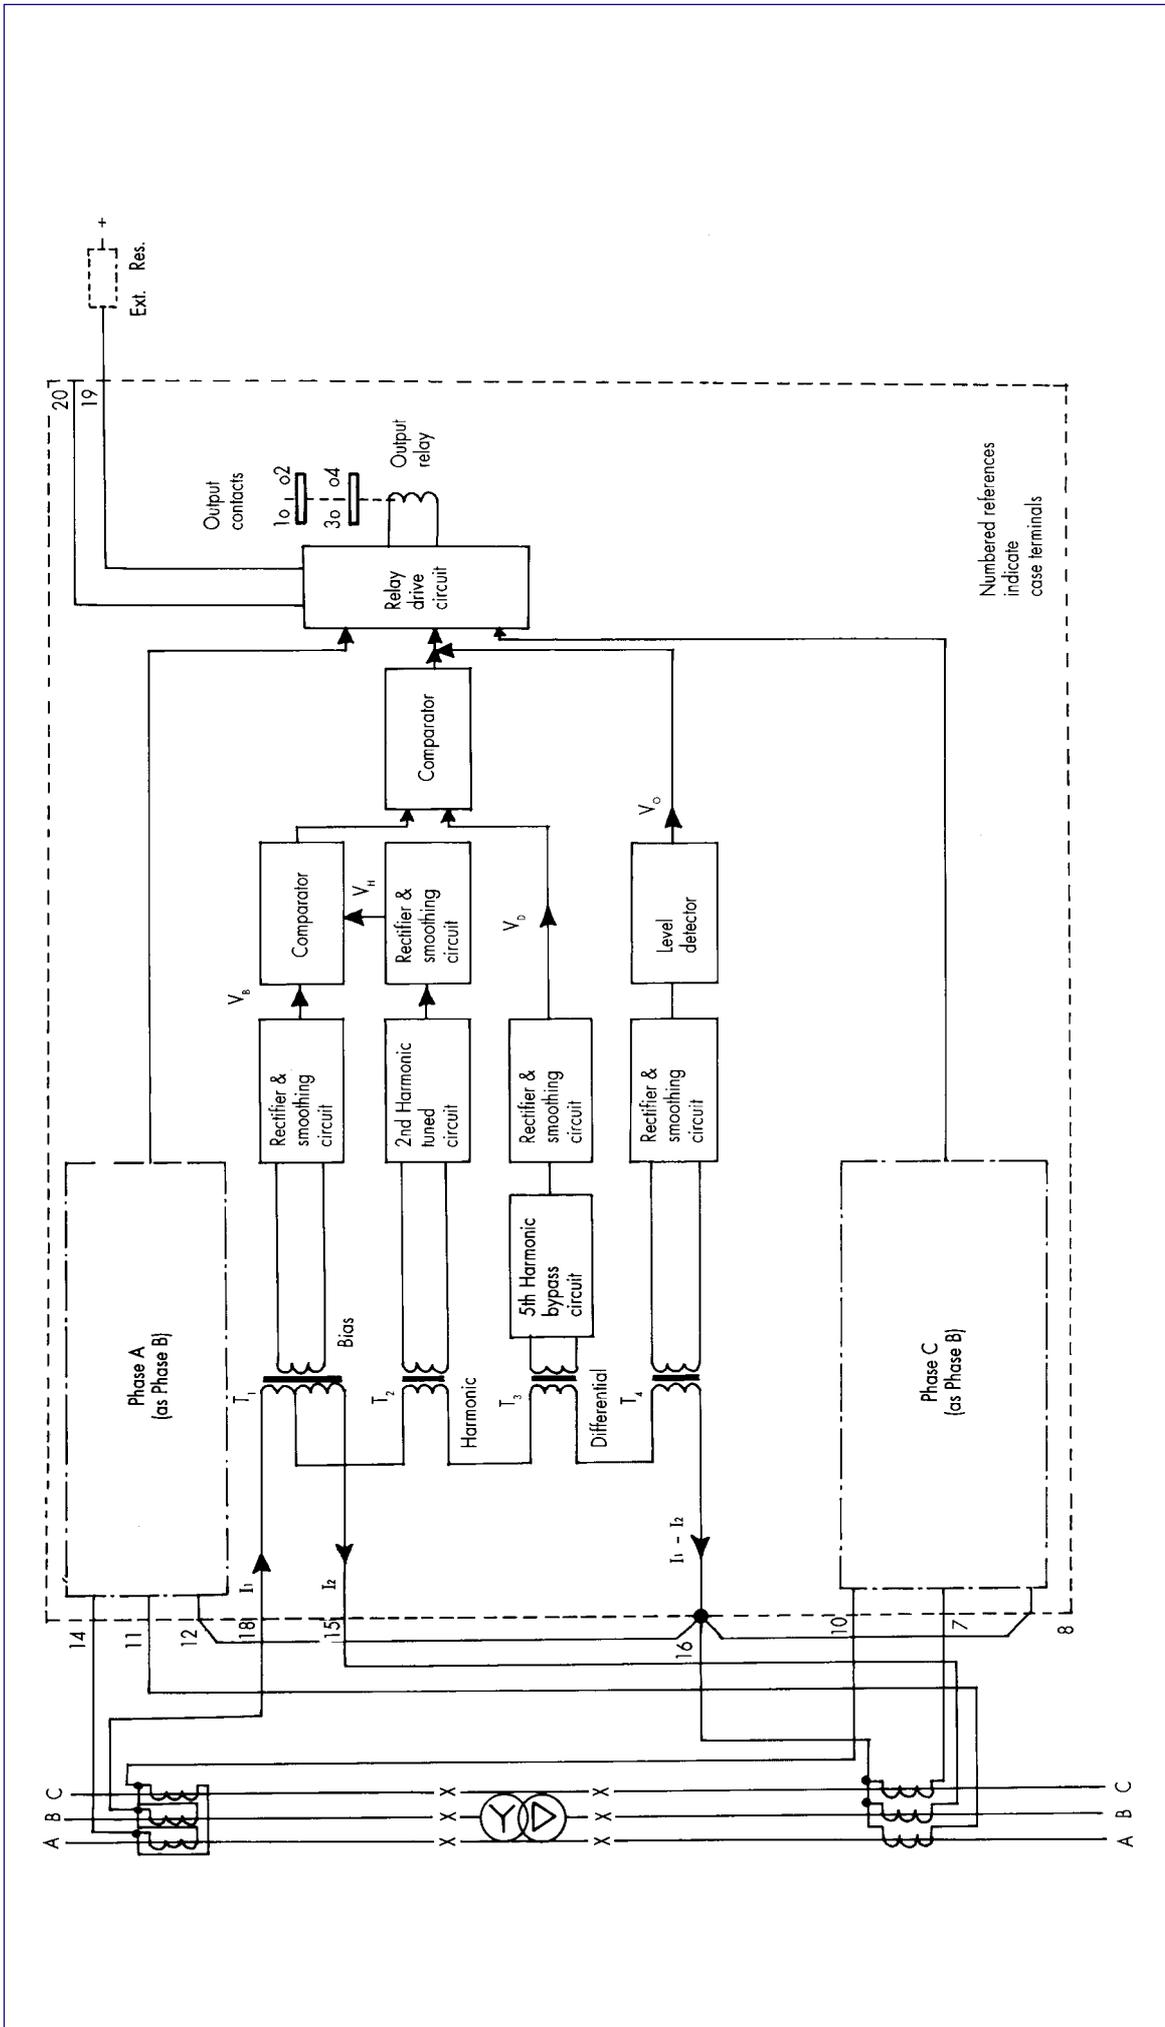
Figure 1:
Block schematic diagram of DTH 31

Figure 1 – block schematic diagram – shows a typical application with a three-phase two-winding transformer.

Input currents I_2 and I_1 from the power transformer line CTs are added vectorially in the centre tapped restraint bias transactor T_1 . Three taps in each half of the transactor primary enable bias settings of 15%, 30% and 45% to be obtained. The output of T_1 is full wave rectified and smoothed to

obtain the restraint bias voltage level V_B . The centre tap of T_1 is connected to the differential circuit which comprises transactors T_2 , T_3 and current transformer T_4 connected in series. A tuned circuit which includes the secondary of T_2 is arranged to resonate at the second harmonic frequency. The output of this circuit is rectified and smoothed to obtain the harmonic restraint voltage level V_H . In addition, outputs of transactor T_3 and current transformer T_4 are rectified and smoothed to obtain the differential voltage V_D and the highset voltage level V_O respectively.

The greater of the two restraining voltage levels V_B and V_H is detected in one comparator and compared in magnitude with the differential operating voltage level V_D in a second comparator stage. When the operate voltage exceeds the restraining voltage by more than a preset amount, the second comparator produces an output to operate the common relay drive circuit. The highset voltage level V_O operates the relay drive circuit if the differential current exceeds ten times the rated current.

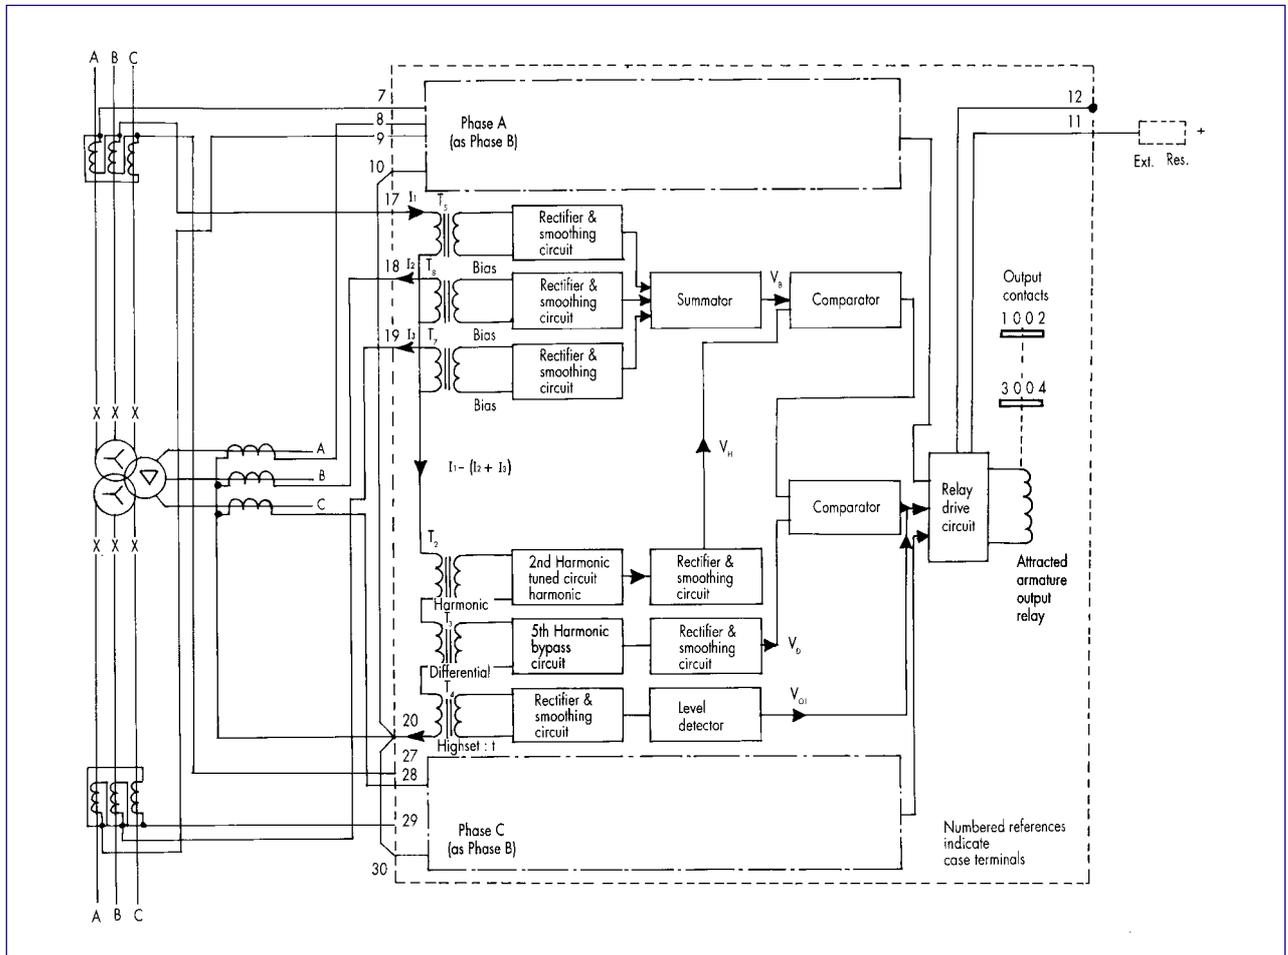
Figure 2:
Block schematic diagram of DTH 32

Figure 2 – block schematic diagram – shows an application with a three-phase three-winding transformer. Because current reversal is possible, the three inputs I_1 , I_2 , and I_3 cannot be added vectorially. Consequently, inputs to the DTH 32 are fed to separate transactor/rectifier circuits, and the dc voltage outputs added to produce a bias voltage V_B . All other circuitry is similar to that of the DTH 31 relay.
