**REPORT OF THE INQUIRY COMMITTEE ON  
GRID INCIDENT IN NORTHERN REGION  
ON 27<sup>th</sup> JANUARY, 2007.**

**1.0 INTRODUCTION**

- 1.1 A grid incident occurred in Northern Region in early morning hours on 27.1.2007, due to heavy fog in the region, resulting in 201 trippings on the 400 kV and 220 kV system as recorded at NRLDC (including single pole autoreclosures). These trippings resulted in a situation where at 0812 hours, 53 lines (400 kV and 220 kV) were out, resulting in backing down / load shedding.
- 1.2 Four incidents of loss of a 400 kV or 220 kV bus also occurred during this incident at 400 kV NTPC Dadri, 220 kV Bawana, 220 kV Auraiya and 220 kV Panipat (BBMB). The latter two caused a loss of generation to the extent of 500 MW.
- 1.3 Central Electricity Authority vide its order No. CEA/BC/Delhi/1/2007 dated 27.1.2007 (**Annexure - I**) constituted a Committee comprising the following members to inquire into the incident and recommend remedial measures to avert recurrence of such incidents:

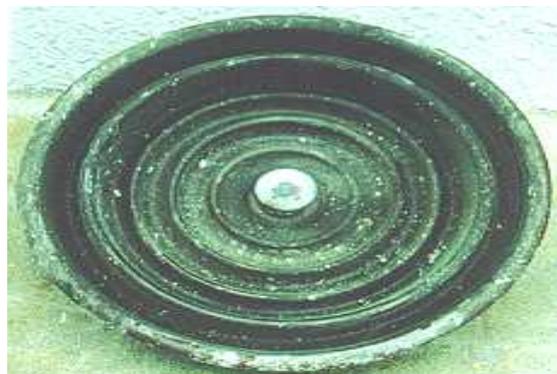
- (i) Industrial development has taken place after line construction (Fig-1)

Fig-1: Pollution Deposits On Insulator Strings Due To Industrial Emissions

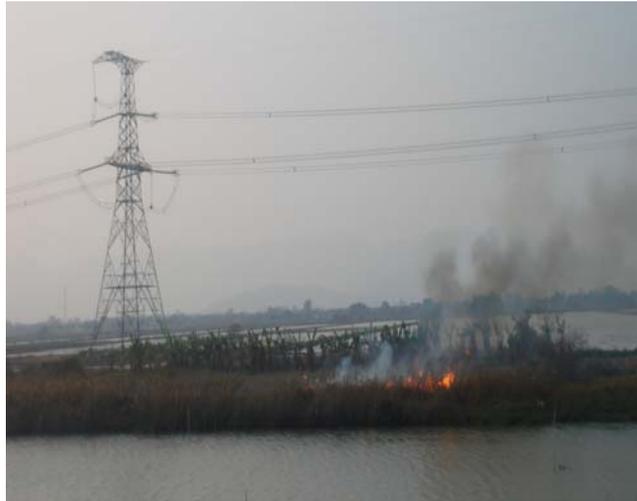
- (iii) Burning of agricultural waste is carried out after harvesting (Fig-2.)

Fig-2: Burning of Agricultural Waste

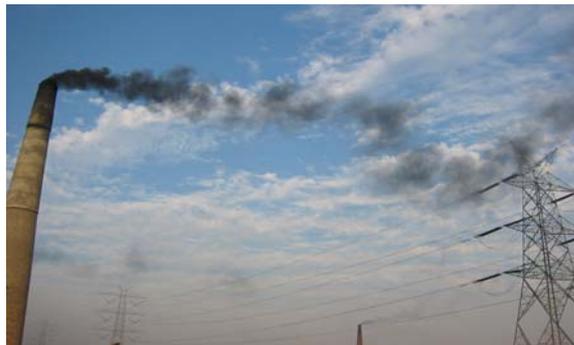
- (iv) Brick kilns are in operation near to transmission lines (Fig-3a&b.)

Fig-3a: Smoke from Brick Kilns polluting Transmission Line

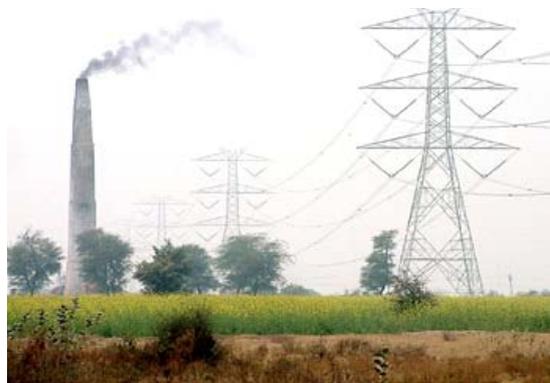
Fig-3b: Smoke from Brick Kilns polluting Transmission Line

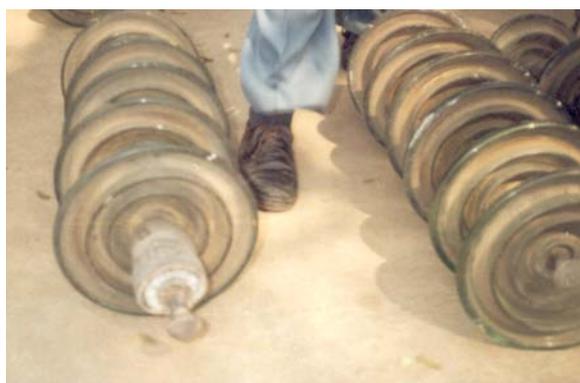
- (v) The normal soil itself has soluble conductive ingredients and there are dust storms and fewer showers (Fig-4.).

Fig-4: Dust Accumulation On Insulators

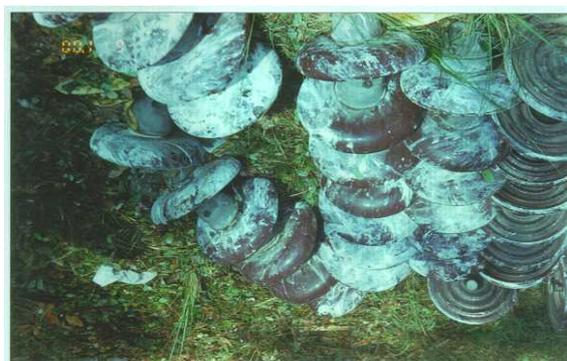
- (vi) There is change in climatic pattern with less magnitude and frequency of rain
- (vii) Birds are nesting on the transmission towers and its excreta falling and accumulating on insulator strings(Fig-5.)

Fig-5: Deposits On Insulator Surface Due To Bird Droppings

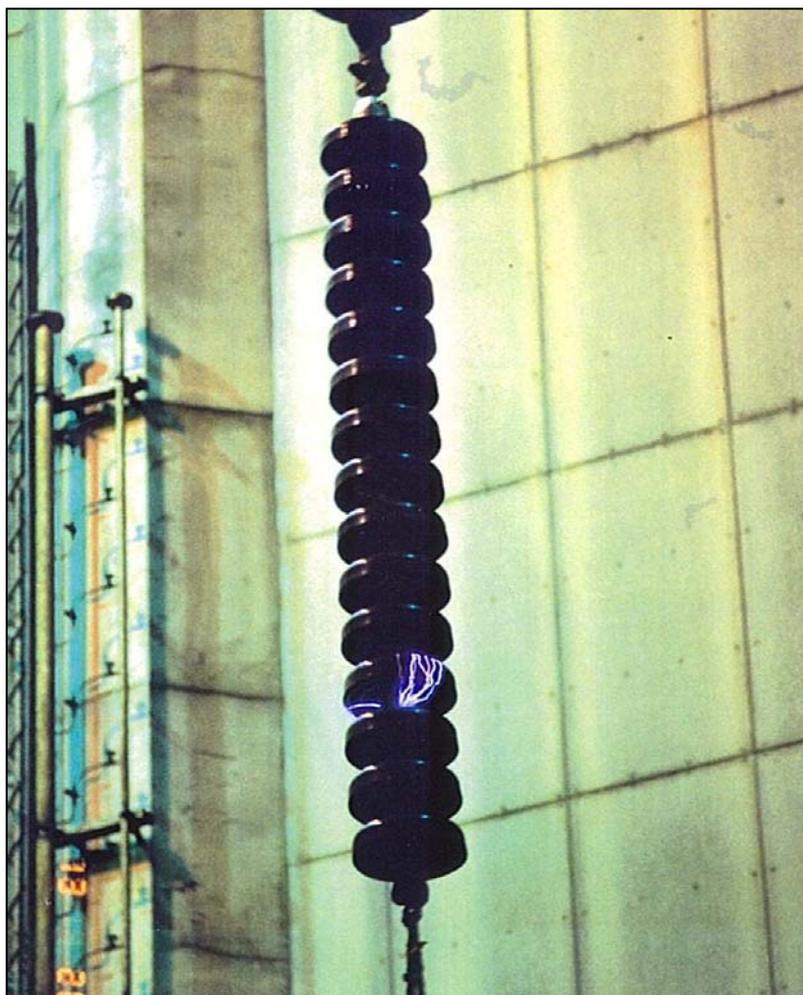
- iii) Wetting of the contamination layer and consequent formation of a conductive layer on the insulator surface causes flow of leakage current through the surface when the insulator is under energized state. The leakage current flow generates heat due to  $I^2R$  losses and it heats the conductive layer. Surface deposit and wetting of deposit is not uniform. In the area of higher current (density around pin) the heat dissipated would be greater and therefore moisture dries more rapidly at these locations leading to the formation of dry bands. These dry bands have higher resistance than of other areas which are still moist. Due to the high resistance, the voltage drop across the dry band also would be more and sometimes become sufficient enough to create an electric arc across the most stressed dry band. Arc short circuit the dry band and heat generated keeps the bands dry and contributes to the overall drying process. Due to short circuiting by the arc the resistance of the dry band is quite low and therefore the leakage current increases further and leading to formation of other dry bands. Arc propagates along the insulator surface. In many cases arc extinguishes while in some cases flashover of insulator unit ( unit 6) take place and the line trips.

Fig-6 :Flashover of a single insulator unit under pollution

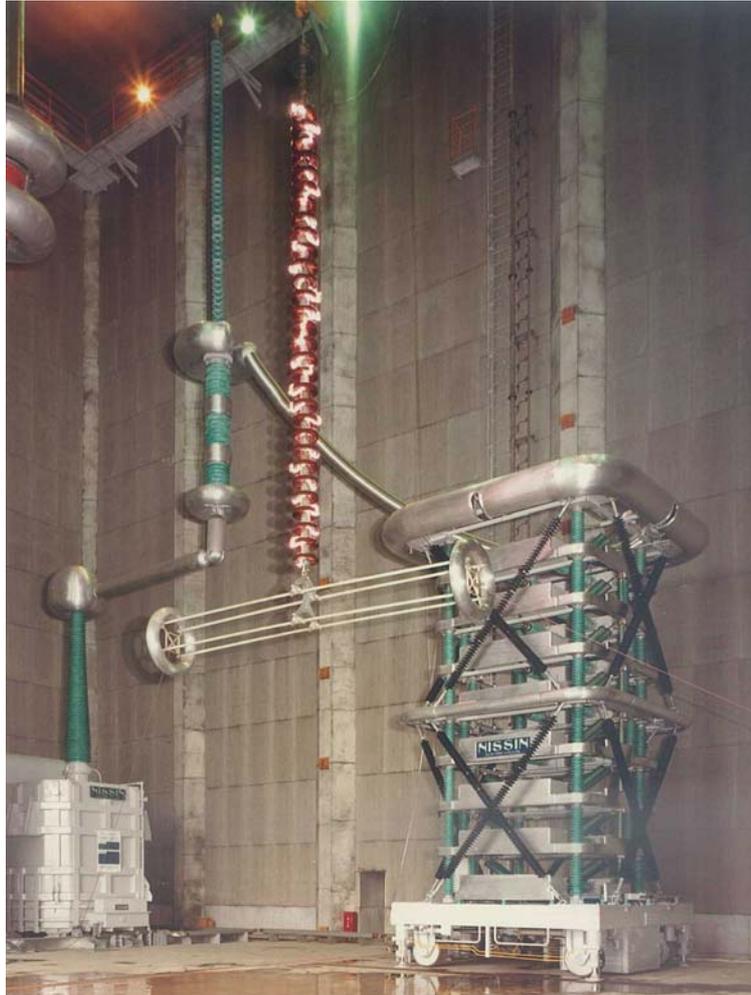
- v) When one insulator unit has flashed over, as explained above, the leakage current flow along other insulator units in the string increases and the dry band arcing gets accelerates and progresses to other insulator units leading to arc cascading on the complete insulator string resulting in insulator string flashover ( figure 7) and line tripping.

Fig -7 : Complete Flashover of an Insulator String under Pollution

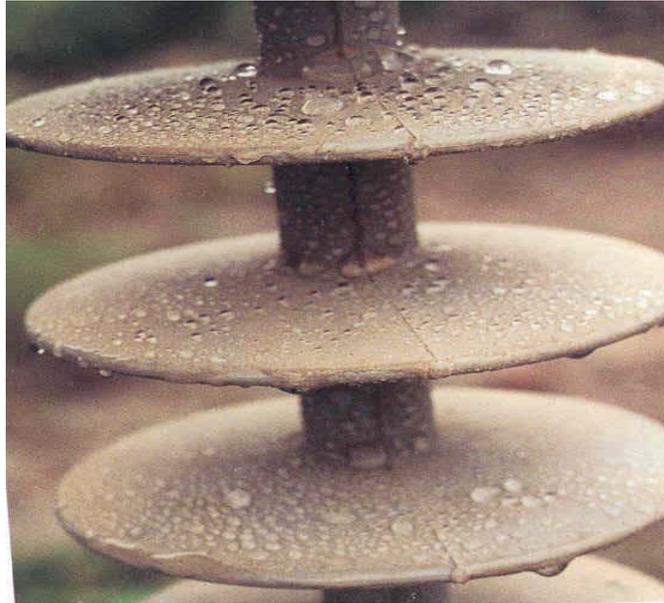
- iv. Use of composite long rod (polymer) insulators with Silicone impregnated (SIR) weather sheds. Composite (Polymer) insulators having silicone/silicone based weather sheds have been recognized for their superior performance in pollution environments. The migration of low molecular weight silicone molecules from the weather sheds onto the contaminant layer accumulated on insulator surface making it hydrophobic (figure 8), reduces the effective soluble contaminant density and therefore reduces the leakage current flow as compared to ceramic insulators. This minimizes the dry-band arcing on the insulator surface. As long as the surface is hydrophobic this behavior is retained and flashover probability under pollution conditions shall be less than that of its porcelain or toughened glass counterpart under identical environments.

Fig-8 :Hydrophobic Surface of Composite long rod insulator

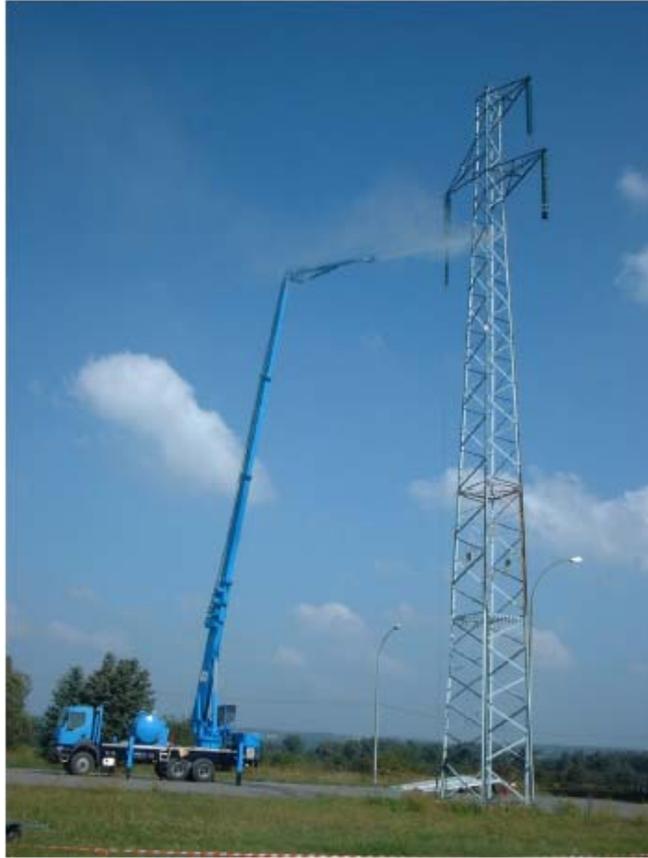
- 7.9.1 The practice adopted by various utilities in the northern region vary from wet cloth cleaning (BBMB) & POWERGRID) to washing of insulator (UPPCL & DTL). It also varies from cleaning of all insulator strings at sites or replacing the insulator string to effect in such cleaning in some selected spans. High pressure water washing has not been employed. Information gathered by the Committee by internet surfing reveals that Southern California Edison<sup>3</sup> are using truck mounted live line insulator washing system. Their truck can carry 1200 to 6000 gallons of water and are equipped with 75 to 100 feet hydraulic actuated boom with nozzle and water pump are capable of discharging 60 gallons per minute at 700Psi. Insulator is washed in about 15 seconds. National Electric Power Company<sup>4</sup>, Amman (NEPCO) after training their personnel and using two mobile skid mounted insulator washing units carried out live line washing of 808 towers of 400 kV transmission line from Aquaba to Amman in 90 days. This line in Jordan was initially energized on 132 kV for 12 Years and have major breakdown when energized on 400kV. It has ESDD of 0.2 mg/sq. cms. After live line washing there was no pollution flashover. NEPCO also has one telescopic boom insulator washer with about 50 meter high nozzle for use on flat agricultural terrain. Live line truck mounted insulator washing systems up to 400 kV and 1000 psi water pressure are also supplied by M/s Wiltron<sup>5</sup> and EGI<sup>6</sup>. Figure-9 illustrate telescope boom insulator washers.

Fig 9 : Telescope Boom Insulator Washer

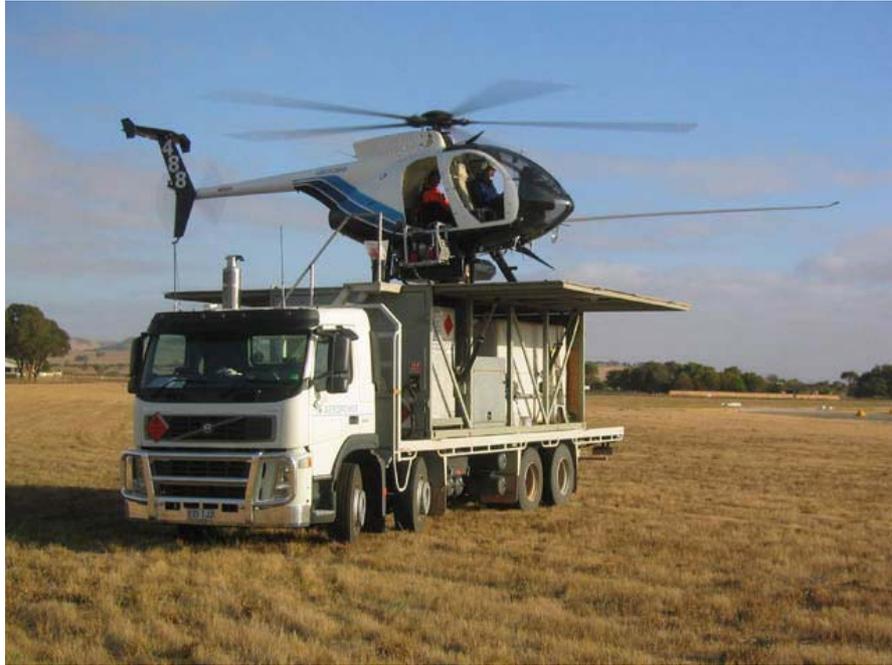
Figure –10: Truck mounted Helipad

Regarding helicopter based live line washing, a number of companies viz Aeropower<sup>7</sup>, Heliwing<sup>8</sup>, Haverfield<sup>9</sup>, USA airmobile<sup>10</sup>, Mt. Hutt helicopter corporation<sup>11</sup>, are providing helicopter borne live line washing, indicating that this helicopter borne system is quite in use. M/s Aeropower and Mt. Hutt helicopters uses MD500 helicopter. MD500 helicopter<sup>12</sup> can have useful pay load of 1450 lbs (658 kg) for fuel personnel and cargo. Standard fuel load is 400 lbs.(60 gallons, 1 gallon=3.7854 liters) and fuel burn rate of 180 lbs. thus it can fly for 2.2 hours before refueling. It can hover and land virtually anywhere (even on landing platform on truck) figure 10 &11. With above fuel load, weight of pilot and one technician, it may require refilling of water in about 10-15 minutes. US patent 4477289 claims washing of 300 strings of 220 kV line in 10 mile (i.e. 16 km) span in 5 hours.operation<sup>13</sup>. Aero power claims productivity of up to 10 times over the ground based methods by using air borne washing techniques. In absence of experience of helicopter based line washing in the country, mobility and speed achievable in India need to be ascertained

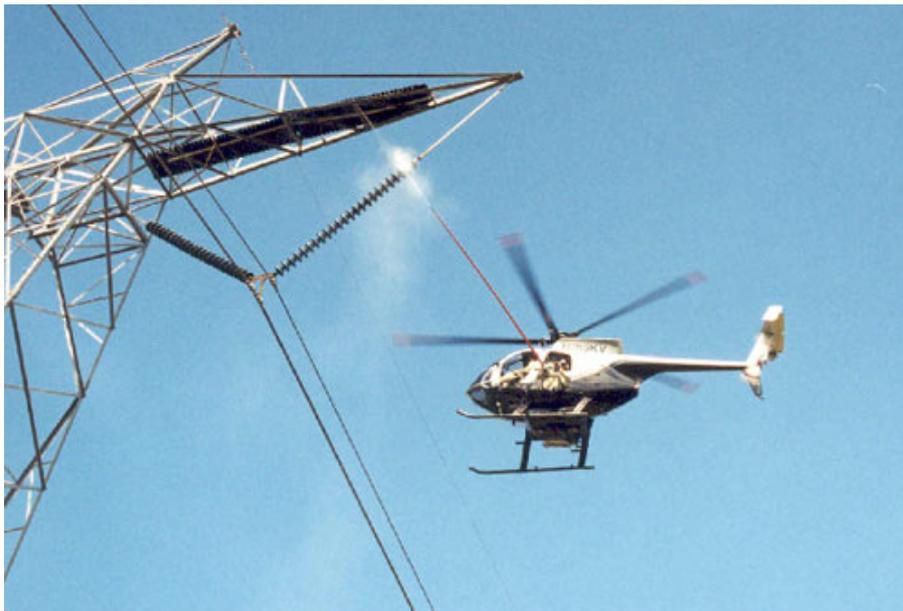
Figure –11: Washing of V- string using Helicopter.
