**Subject:** Analysis of tripping of 400 kV Dadri-Greater Noida line and Navada-Ballabgarh line on 16.12.2013 reportedly due to over voltage.

Analysis of tripping of 400 kV Dadri-Greater Noida line and Navada-Ballabgarh line on  
16.12.2013

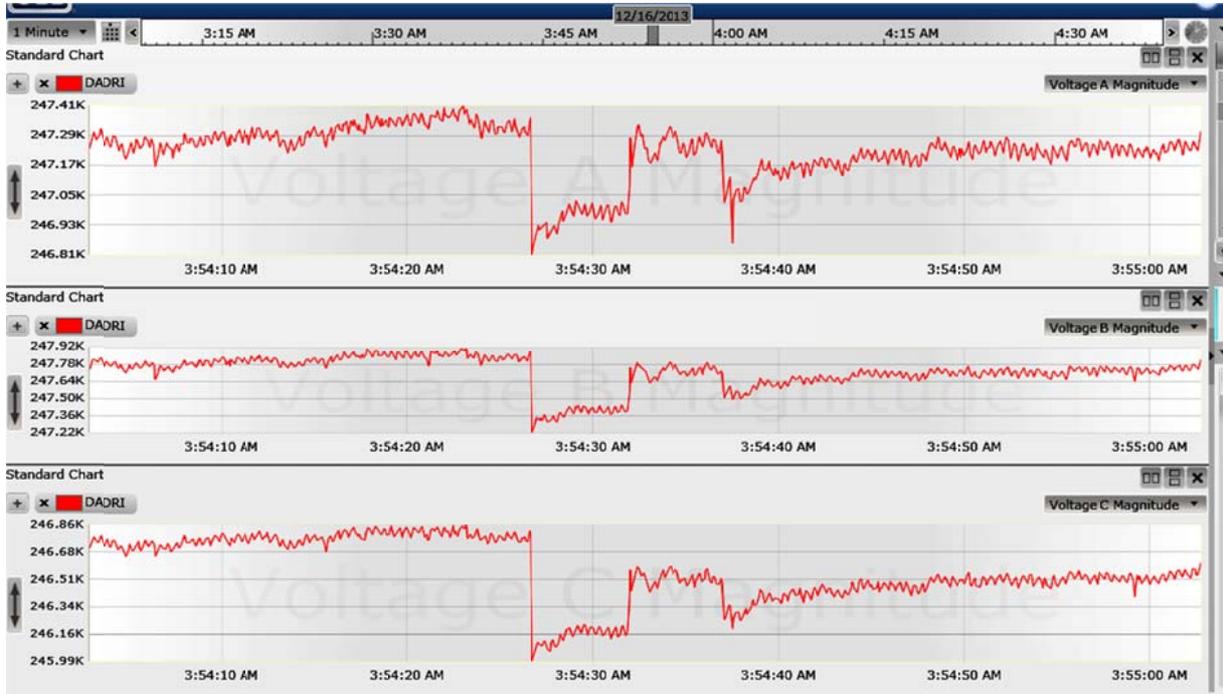
**Dadri Voltage plot**

4.1 The Dadri Phasor Measurement Unit (PMU) voltage plot is given at Annex-III. The PMU plot shows that the voltage at Dadri was below 440 kV. The voltage recorded at Dadri is also reported to be about 436 kV. This is definitely high voltage but not high enough to cause tripping of the line. Generally, high voltage trip setting of transmission lines is at 440 kV with time delay of 5 seconds. Though no representative from NTPC

attended the meeting, the issues was discussed telephonically with Shri PP Francis, GM (OS), NTPC and it emerged that perhaps there was slight positive error in the B-ph CVT output, which led to operation of the relay on high voltage. It was also informed that this had been taken care by modifying relay setting suitably.

5.1 Though the issue of CVT error has been taken care by suitably modifying the relay setting, NTPC should regularly monitor the CVT in question for error. If it shows increasing trend, the CVT should be replaced.
